US EPA RECORDS CENTER REGION 5

11-19-96 M. Mikulka  
Gary Development Landfill  
#1 -- Existing bulldozer at site

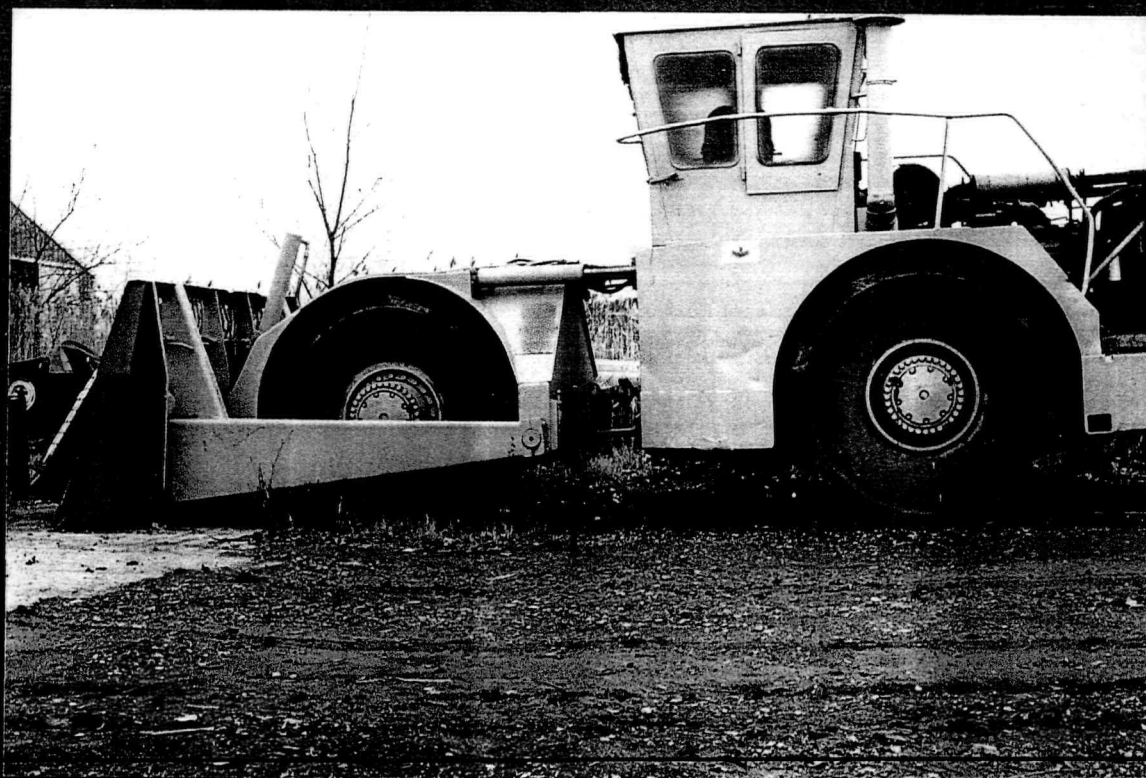
11-19-96 M. Mikulka  
Gary Development Landfill  
#2 -- Existing compactor at site

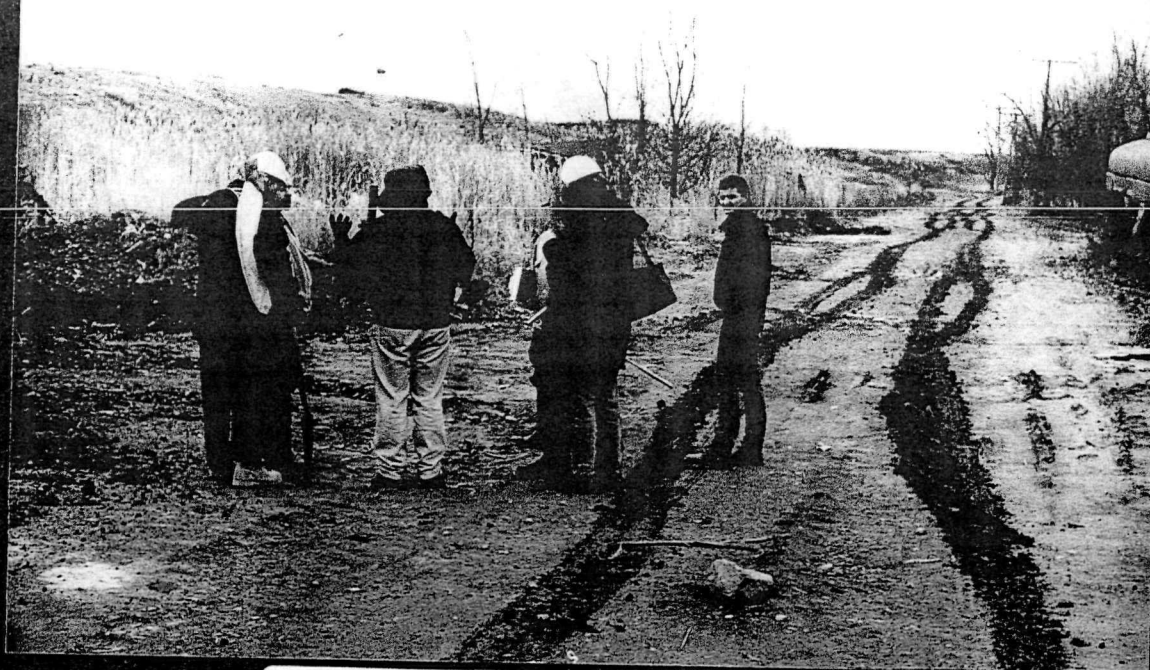
11-19-96 M. Mikulka  
 #3 Gary Development Landfill  
 Inspection team on road at GDC.  
 View from W to E, on S side of  
 LF. Steve Cherry, atty. For GDC  
 facing

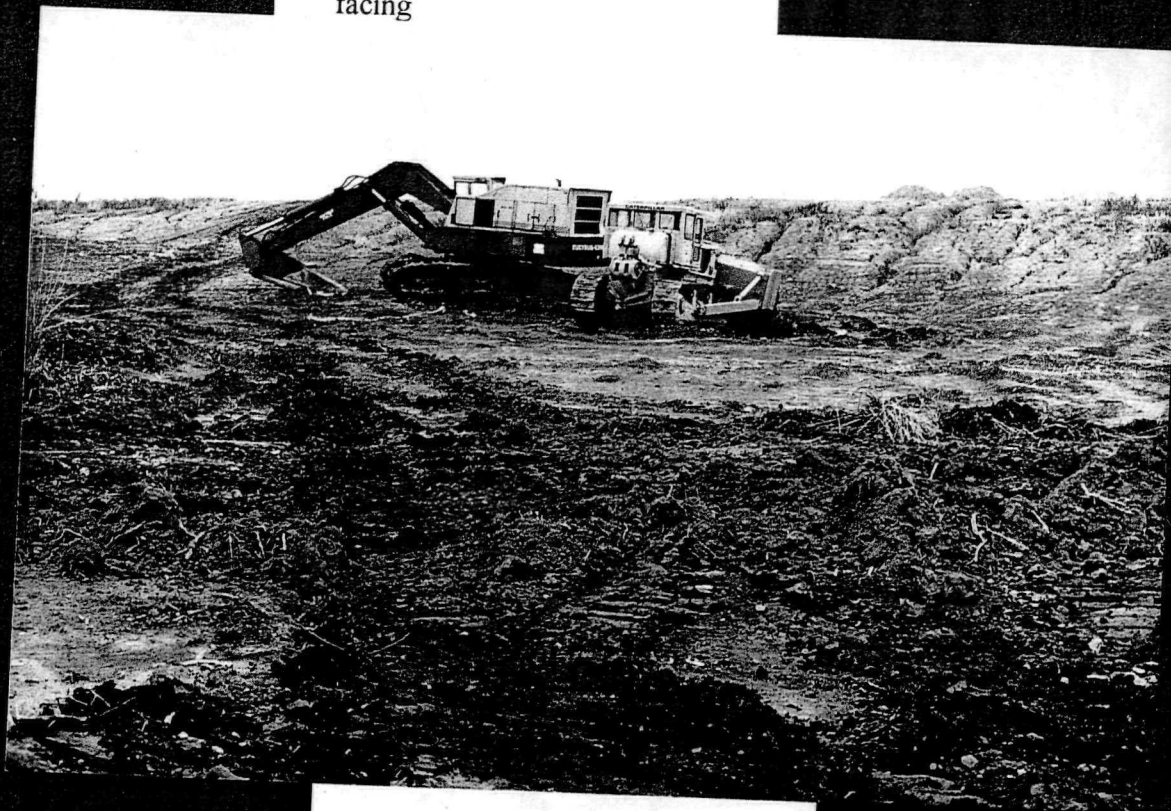
11-19-96 M. Mikulka  
 Gary Development Landfill  
 #4 -- Heavy equipment at site  
 location proposed for storm water  
 management basin. Note heavy  
 erosion of site slopes in  
 background

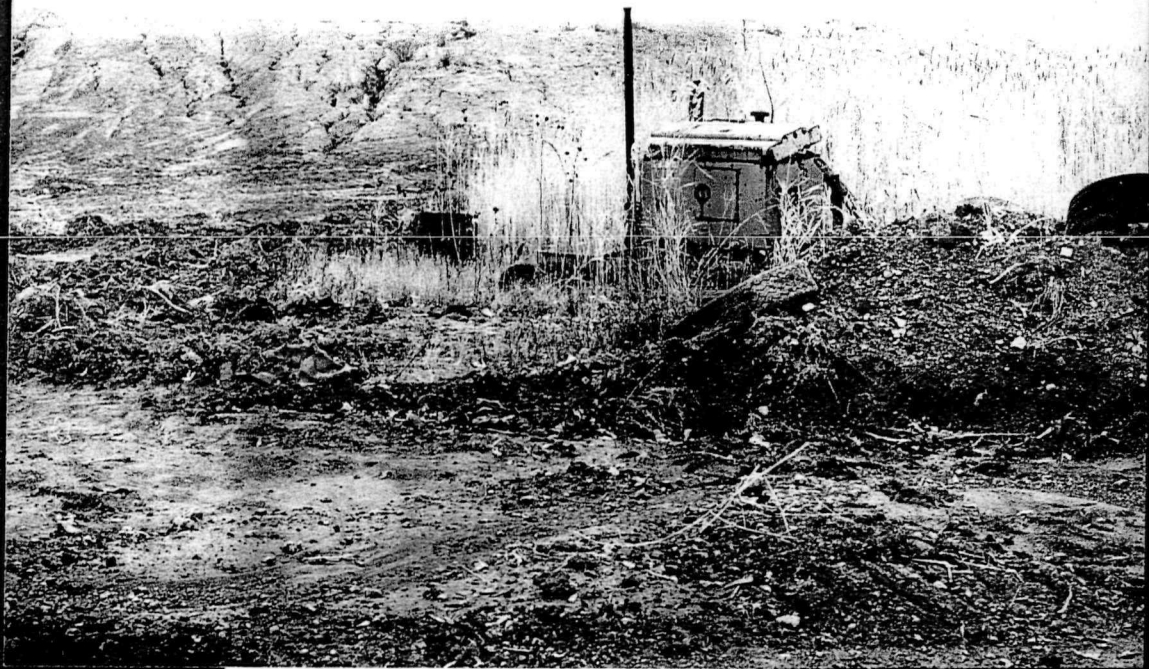
11-19-96 M. Mikulka  
Gary Development Landfill  
#5 -- solid waste (dirt and tires)  
dumped at site. Old equipment  
apparently abandoned. Note site  
erosion.

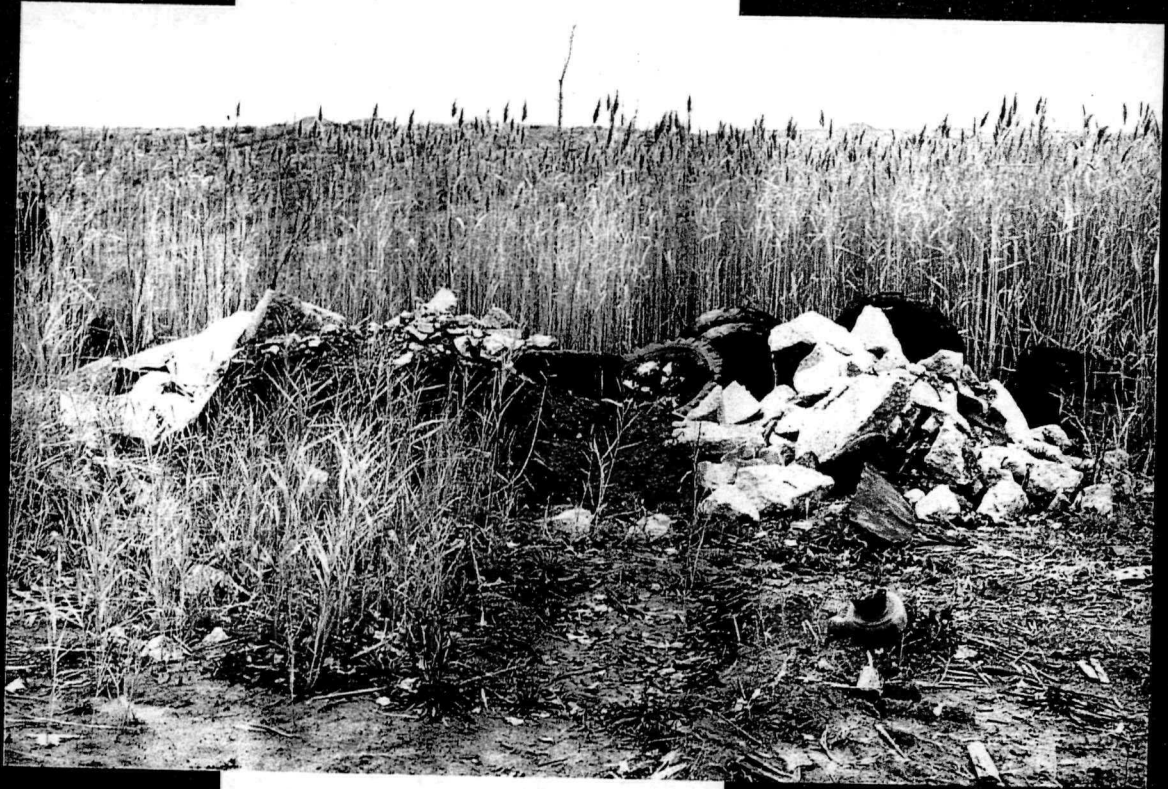
11-19-96 M. Mikulka  
Gary Development Landfill  
#6 -- Concrete rubble and tires  
dumped along road at site.

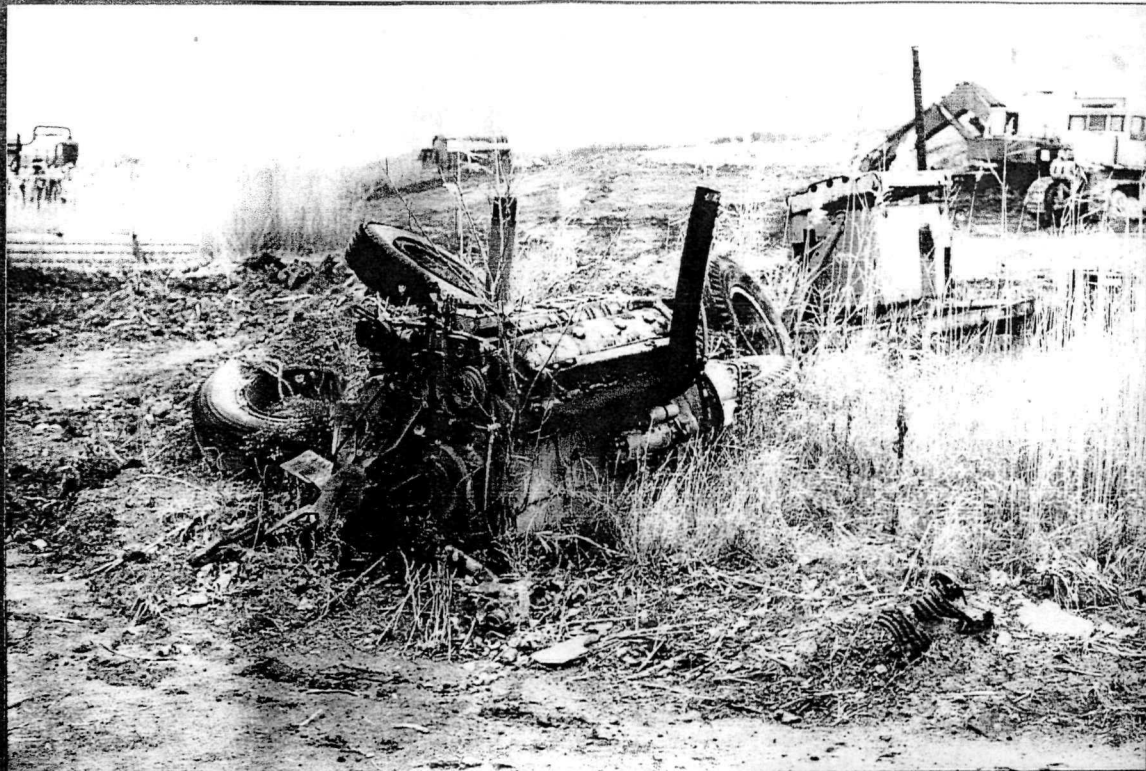
11-19-96 M. Mikulka  
 Gary Development Landfill  
 #7 -- old engine and tires at site.  
 View from road on S side towards  
 NW.

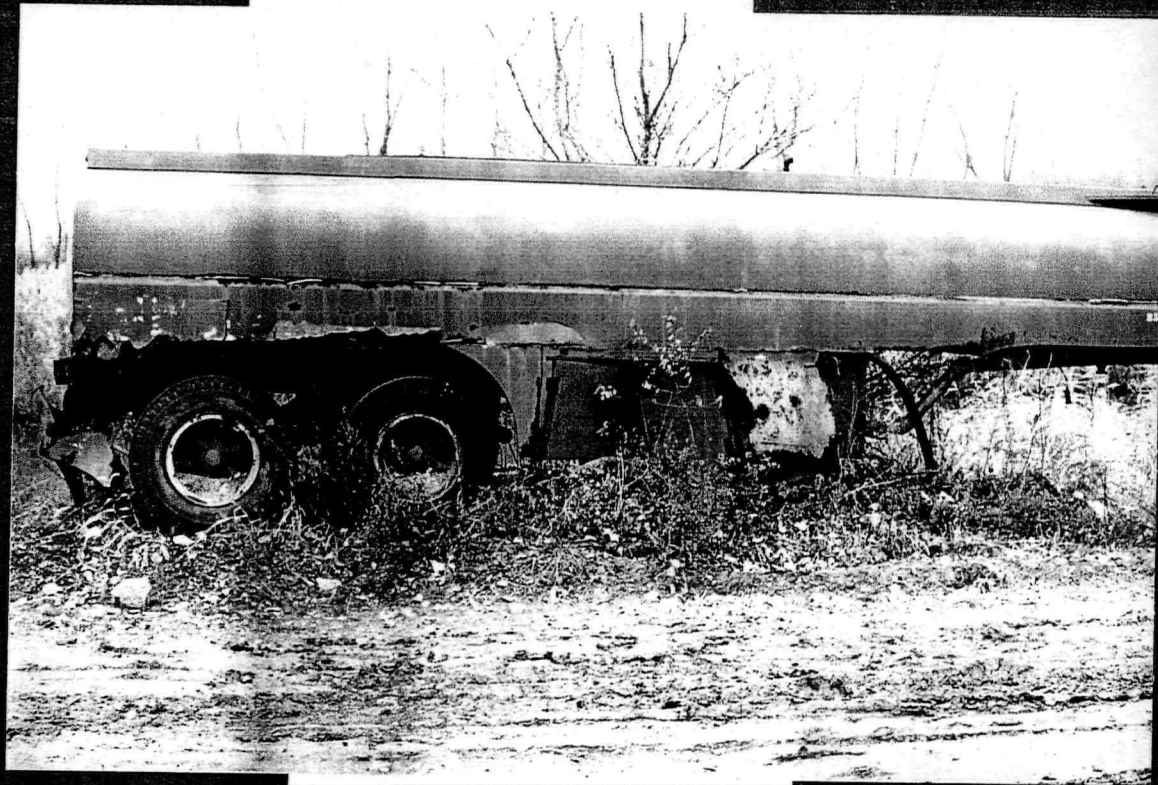
11-19-96 M. Mikulka  
 Gary Development Landfill  
 #8 -- Trailer abandoned at site on  
 S side of road. River behind.

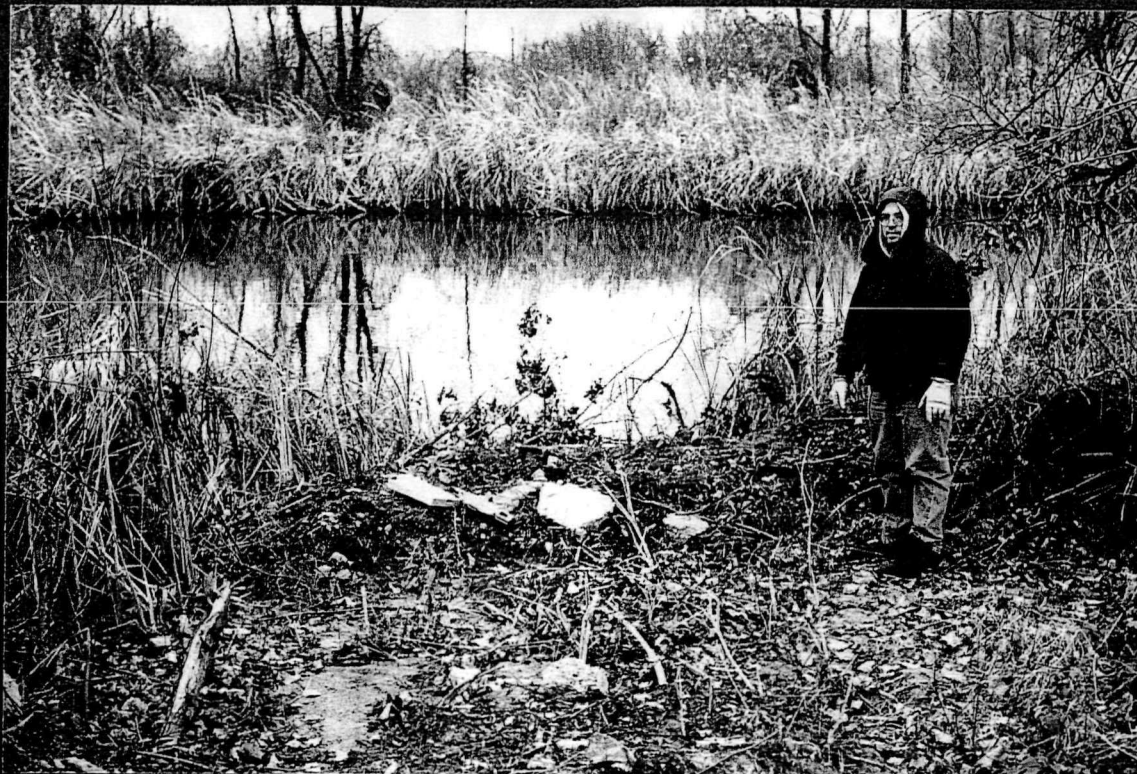
Gary Development Landfill  
#9 -- Concrete and dirt dumped  
near Grand Calumet River at site.  
Kurt Maravolo, IDEM inspector  
adjacent.

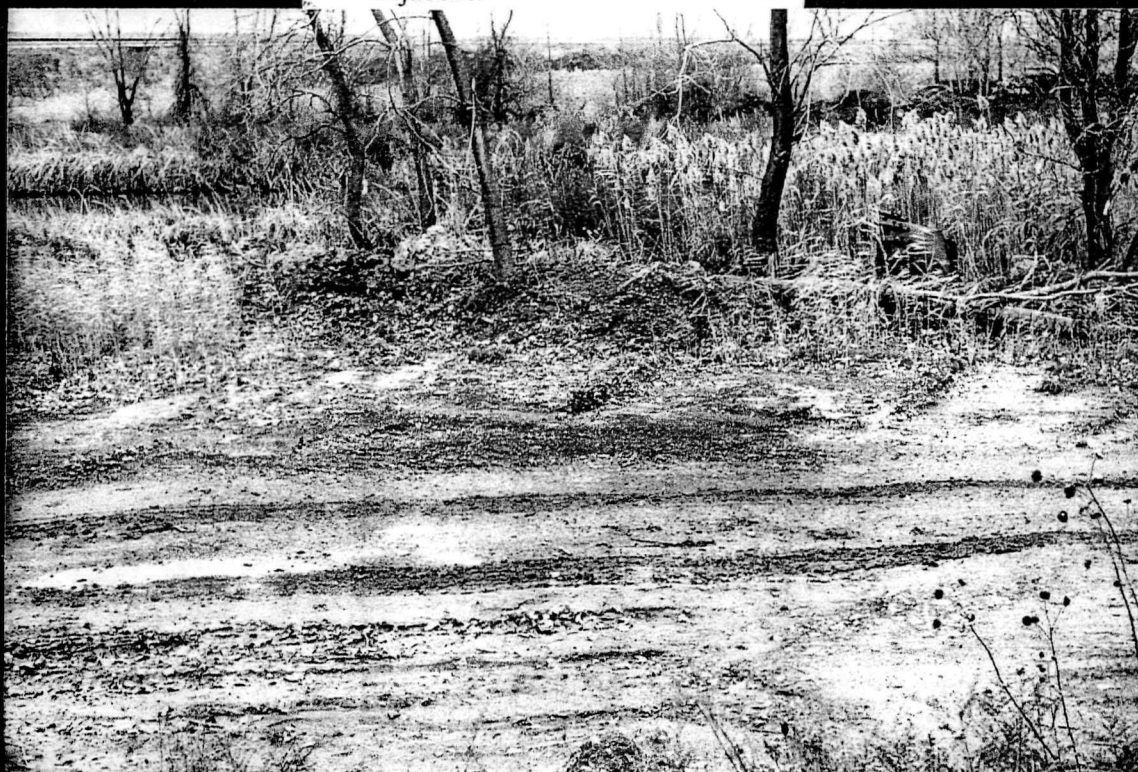
Gary Development Landfill  
#10 -- Material pushed into  
wooded wetland area at site.  
View from road at GDC towards  
Grand Calumet River.

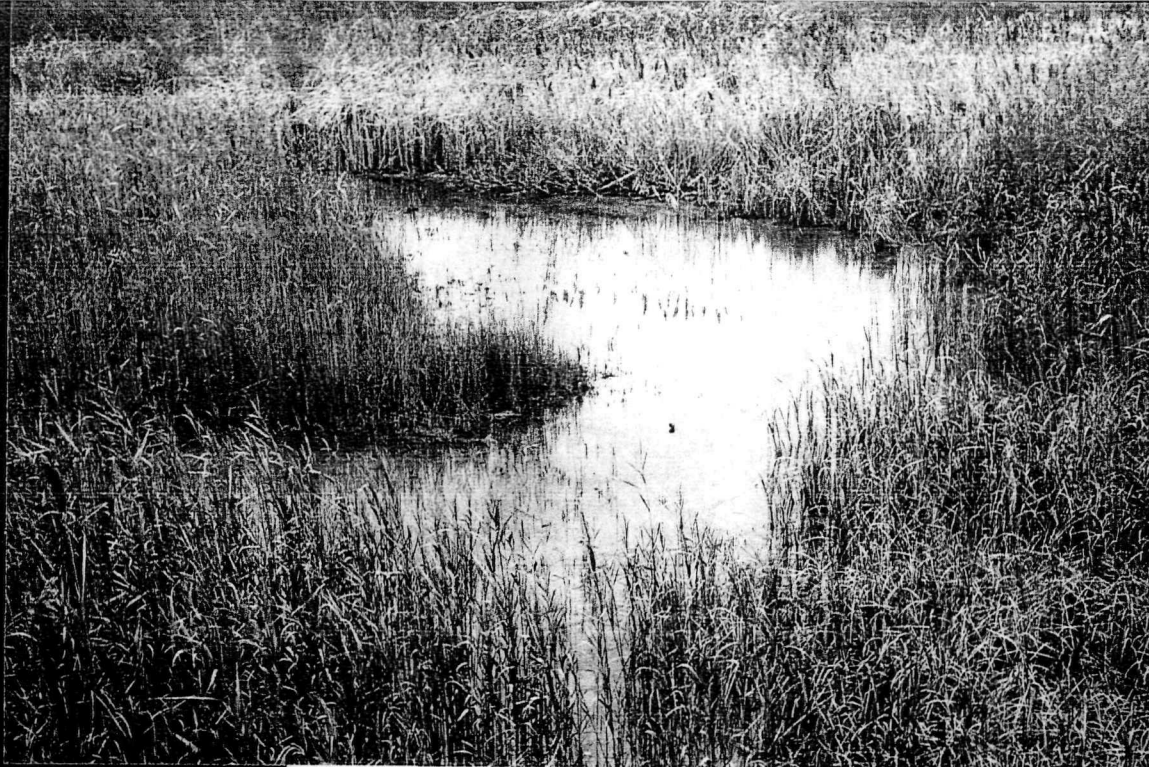
11-19-96 M. Mikulka  
 Gary Development Landfill  
 #11 -- View of ponded area on S  
 side of road at site, at point where  
 road elevates to top of landfill.  
 Ponded area acts a sedimentation  
 basin prior to flow into GCR.

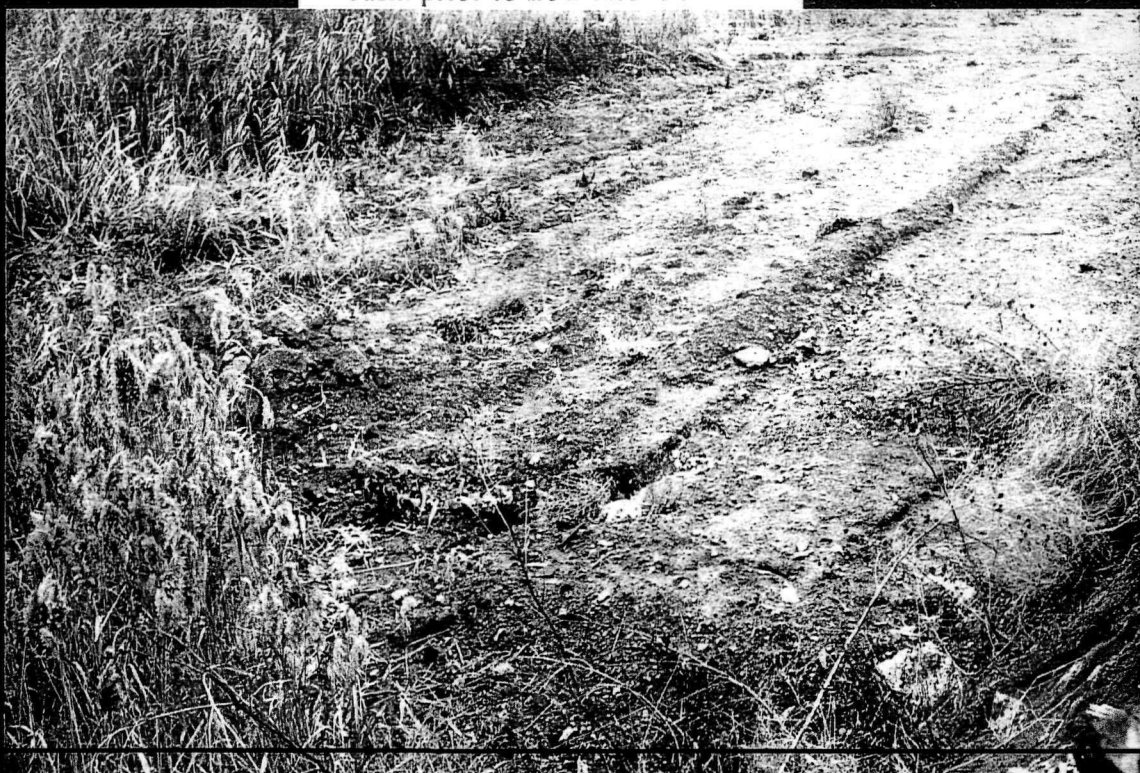
11-19-96 M. Mikulka  
 Gary Development Landfill  
 #12 -- View of area graded from  
 road at site into ponded area seen  
 in photo #11. Berm, which has

been breached, not visible in  
 photo. Runoff from road drains  
 down this slope.

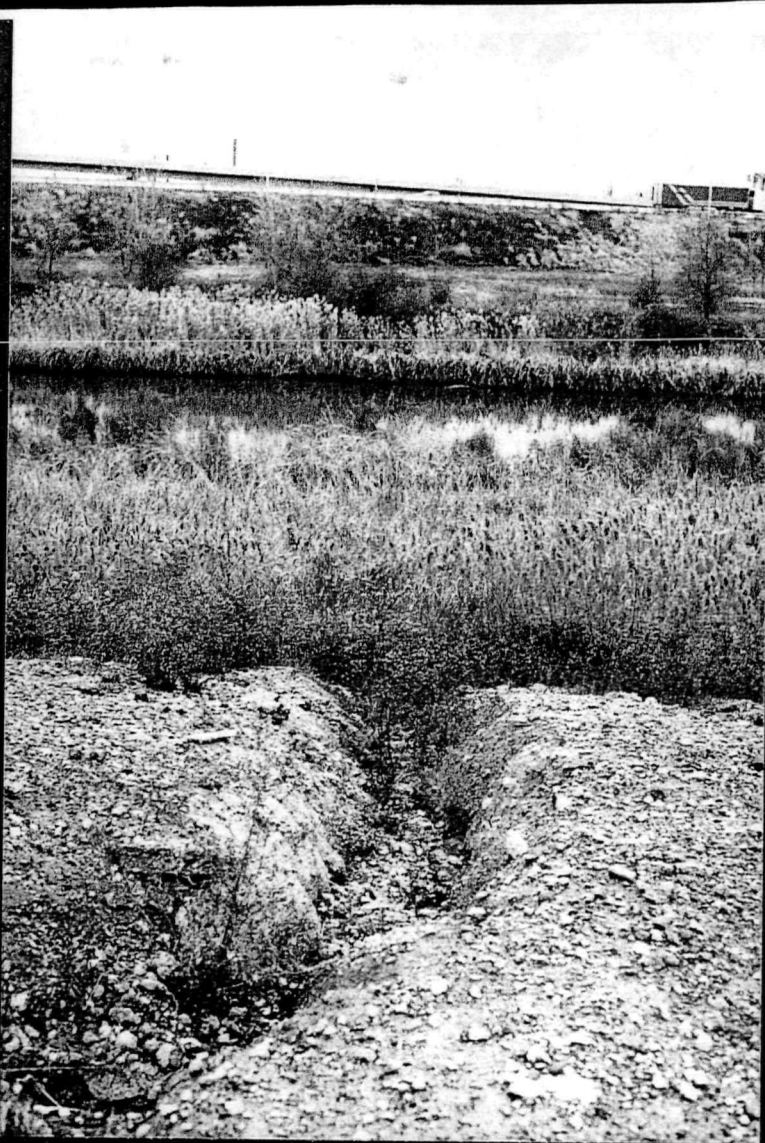
11-19-96 M. Mikulka  
Gary Development Landfill  
#13 -- Deep ravine caused by  
surface runoff; estimated depth,  
2'. Runoff drains towards  
wetlands area @ SE side of  
landfill. GCR in background.

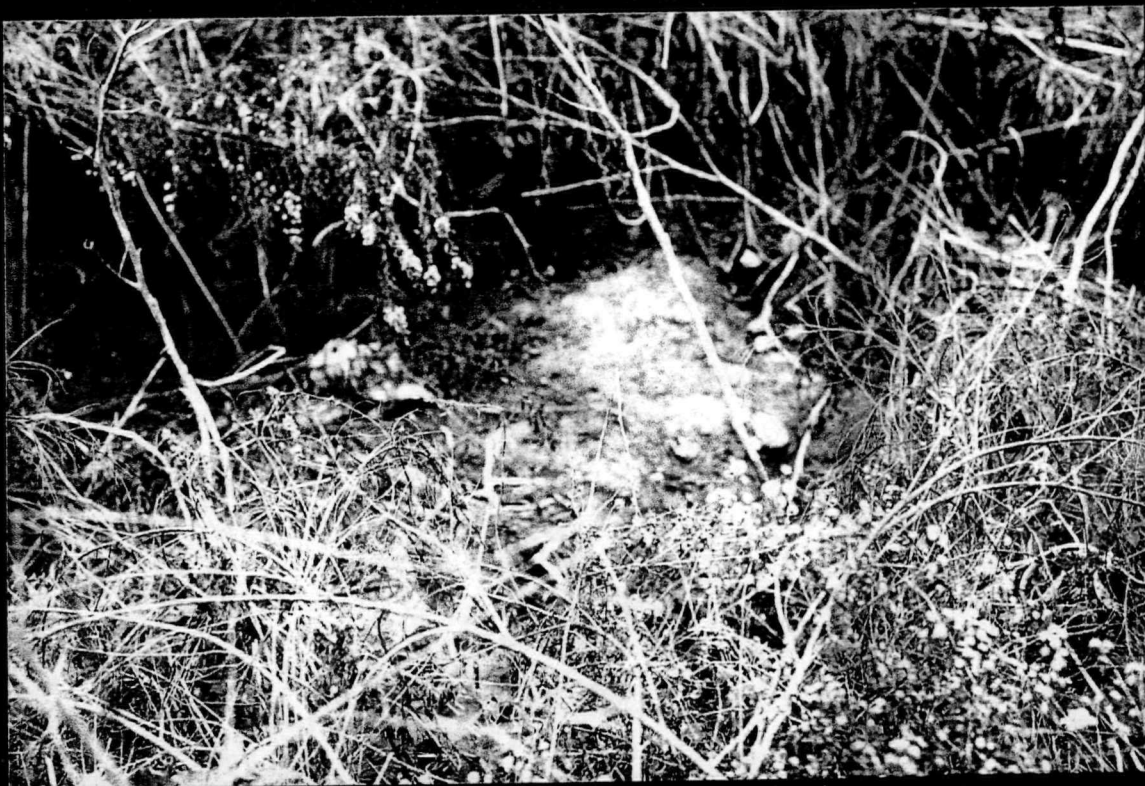
11-19-96 M. Mikulka  
Gary Development Landfill  
#14 -- View of ditch on E. Side of  
Property. Heavily eroded, but  
overgrown. Ditch conveys runoff  
from E. Side of Property to  
wetlands area/GCR.

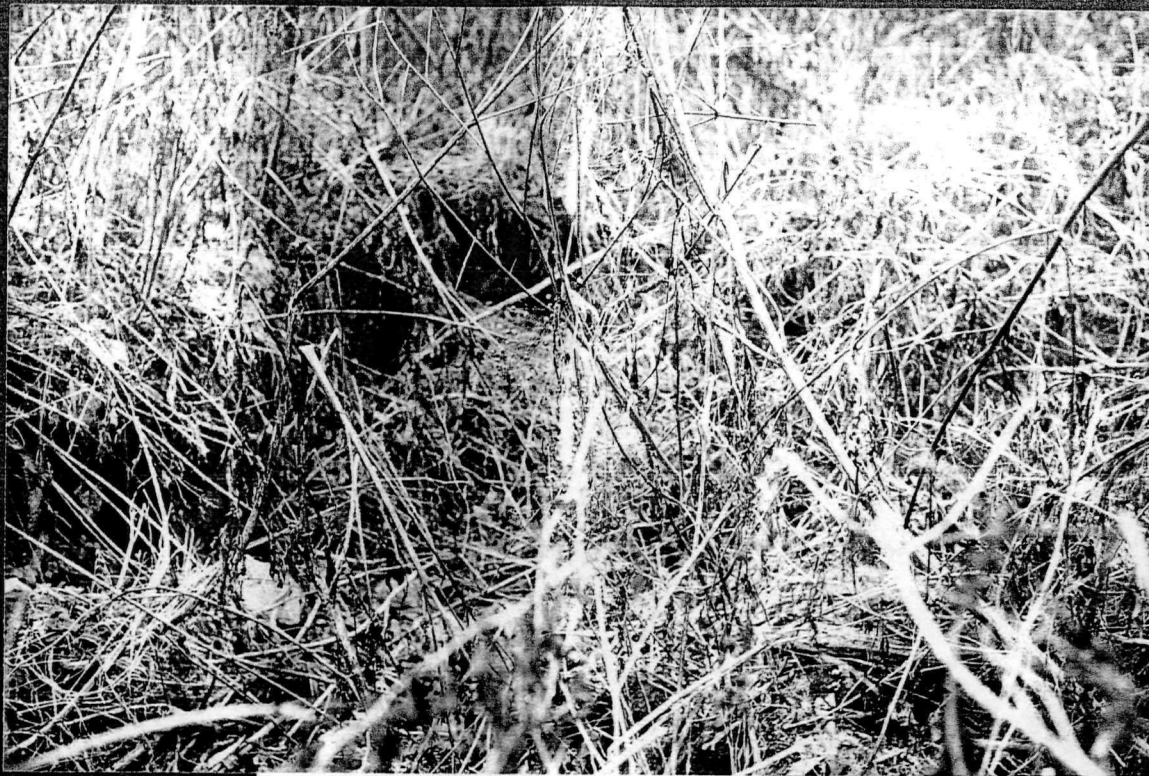
11-19-96 M. Mikulka  
 Gary Development Landfill  
 #15 -- View of ditch on E. Side of  
 property as it meanders towards  
 wetlands area on SE side of GDC.  
 See #13.

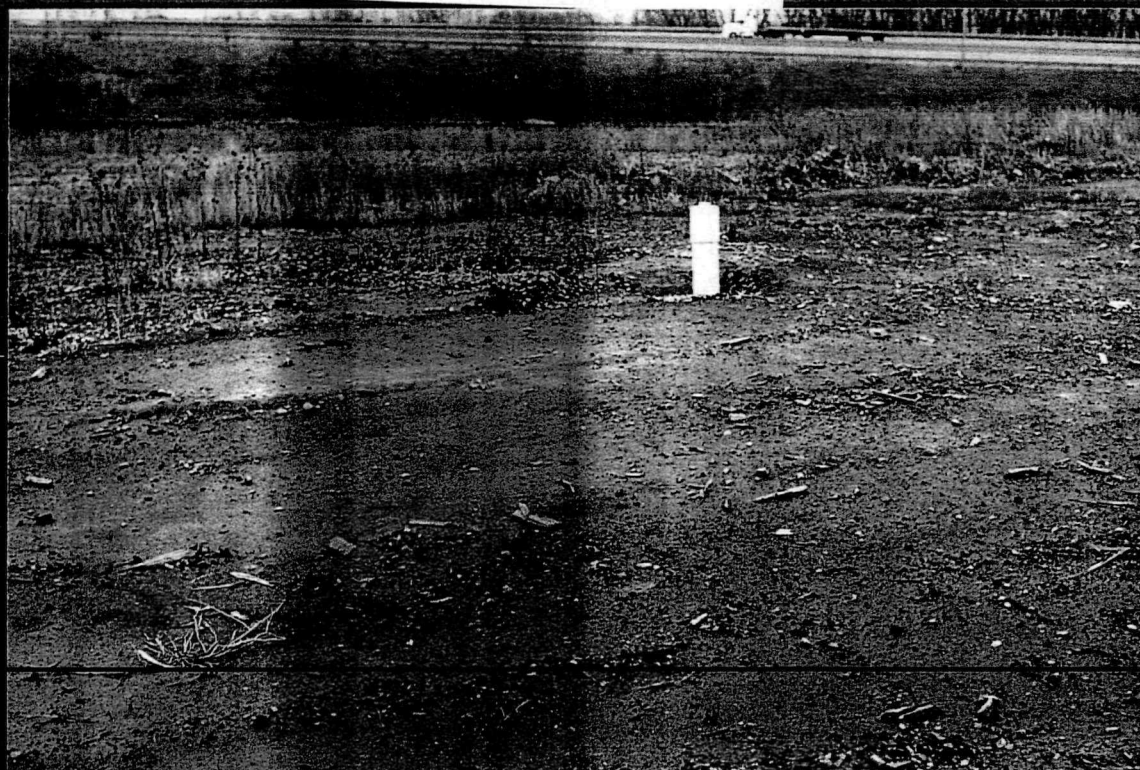
11-19-96 M. Mikulka  
 Gary Development Landfill  
 #16 -- gas recovery well (typical)  
 installed at GDC. Note lack of  
 vegetative cover on the 1-16U

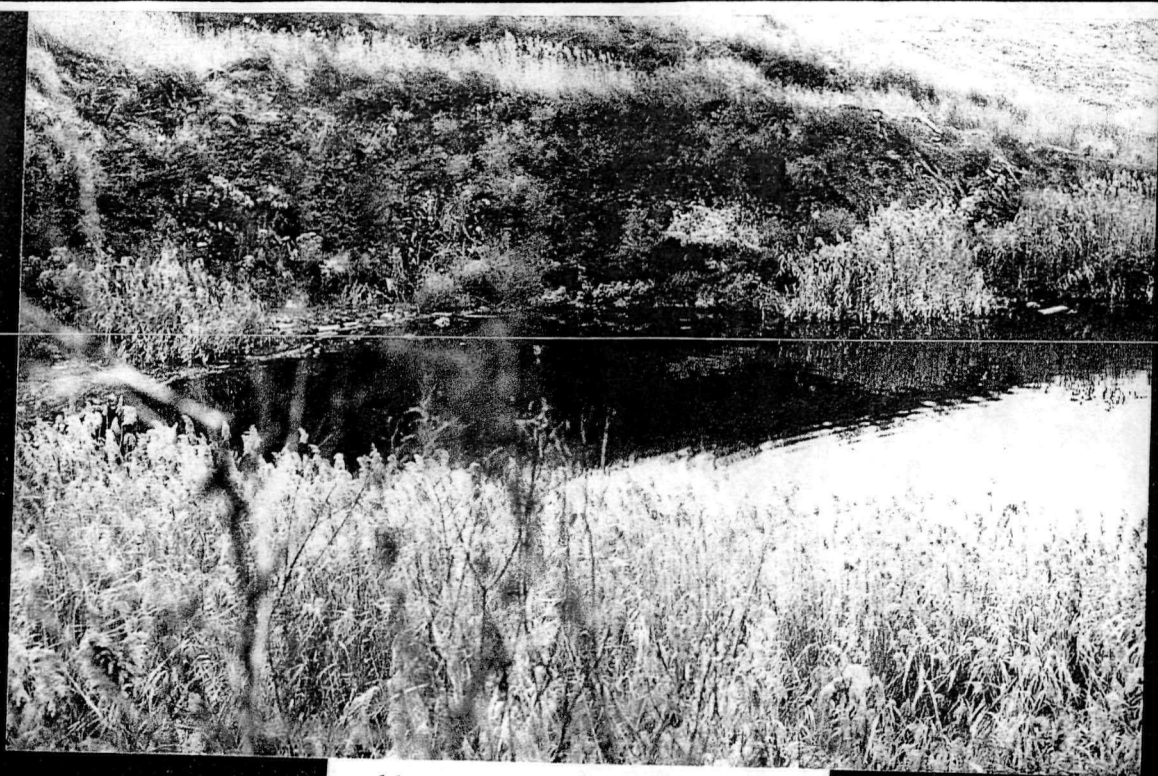
11-19-96 M. Mikulka  
 Gary Development Landfill  
 #17 -- eastern portion of  
 leachate/storm water collection  
 pond on north side of Property, as  
 viewed from north property  
 boundary.

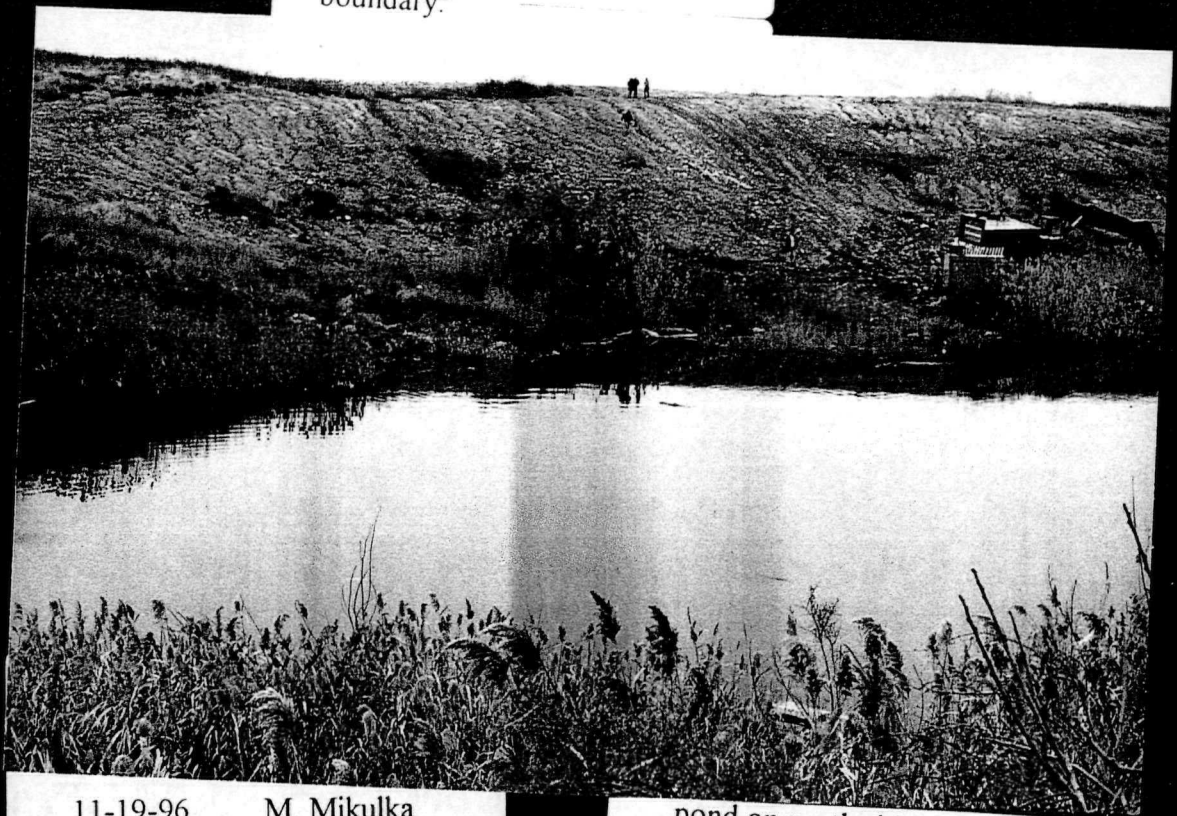
11-19-96 M. Mikulka  
 Gary Development Landfill  
 #18 -- View of central portion of  
 leachate/storm water collection

pond on north side of Property, as  
 viewed from north property  
 boundary. Shows north face of  
 landfill. Note lack of vegetative  
 cover and rill erosion.

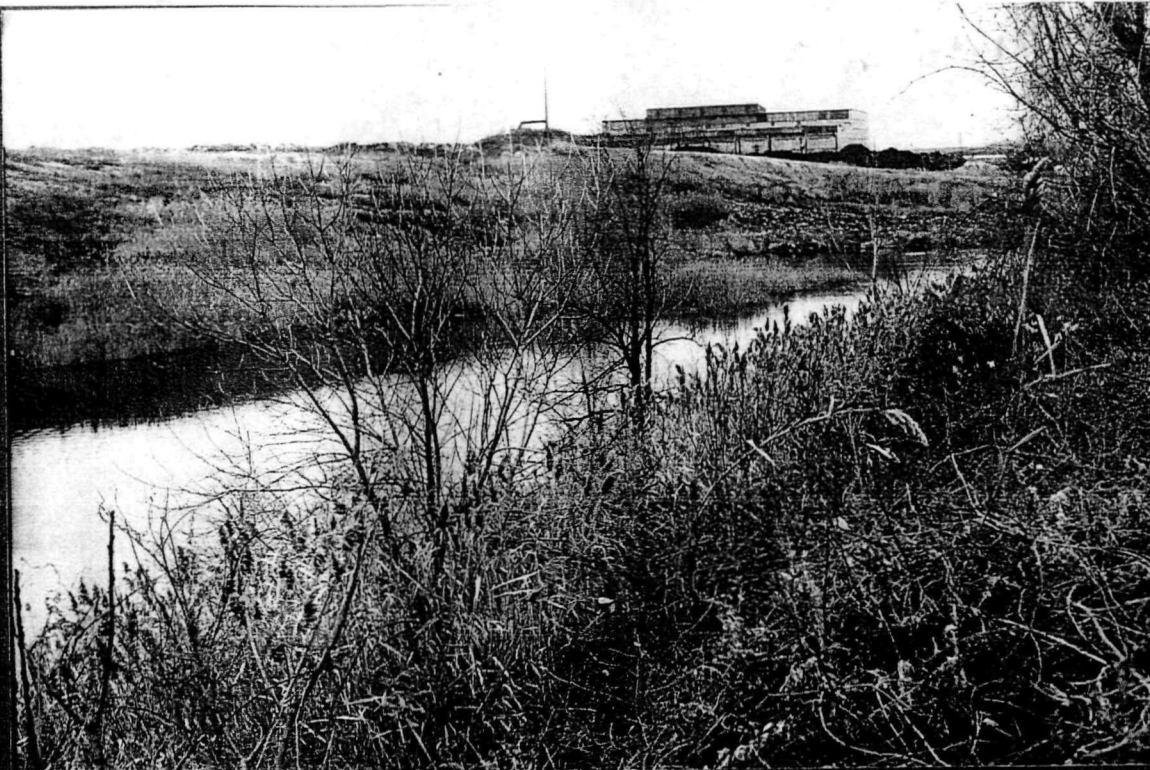
11-19-96 M. Mikulka  
Gary Development Landfill  
#19 -- View of western portion of  
leachate/storm water collection  
pond on north side of GDC

Property. Building in background  
is AMG Resources facility, which  
is due west of GDC site. At top of  
pond, demolition debris can be  
seen.

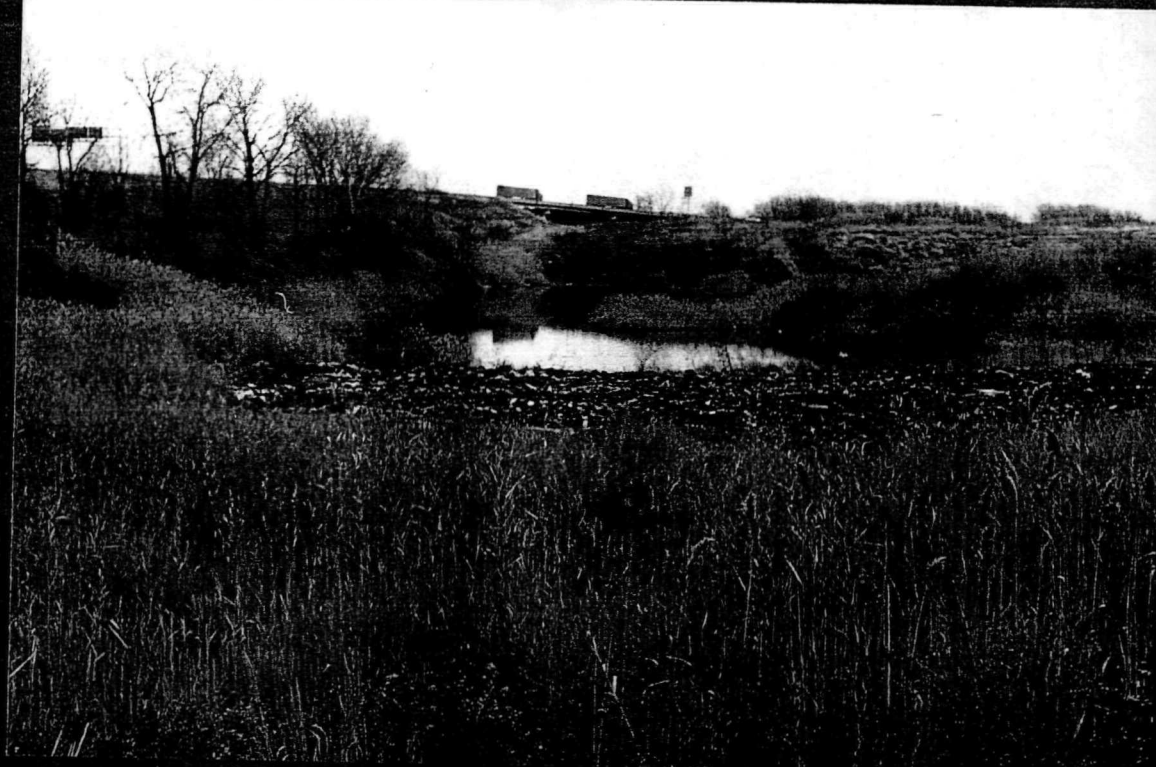
11-19-96 M. Mikulka  
Gary Development Landfill  
#20 -- View of leachate/storm  
water collection pond on N. Side

of GDC Property, as viewed west  
to east. Note Tollway exit ramp in  
background.

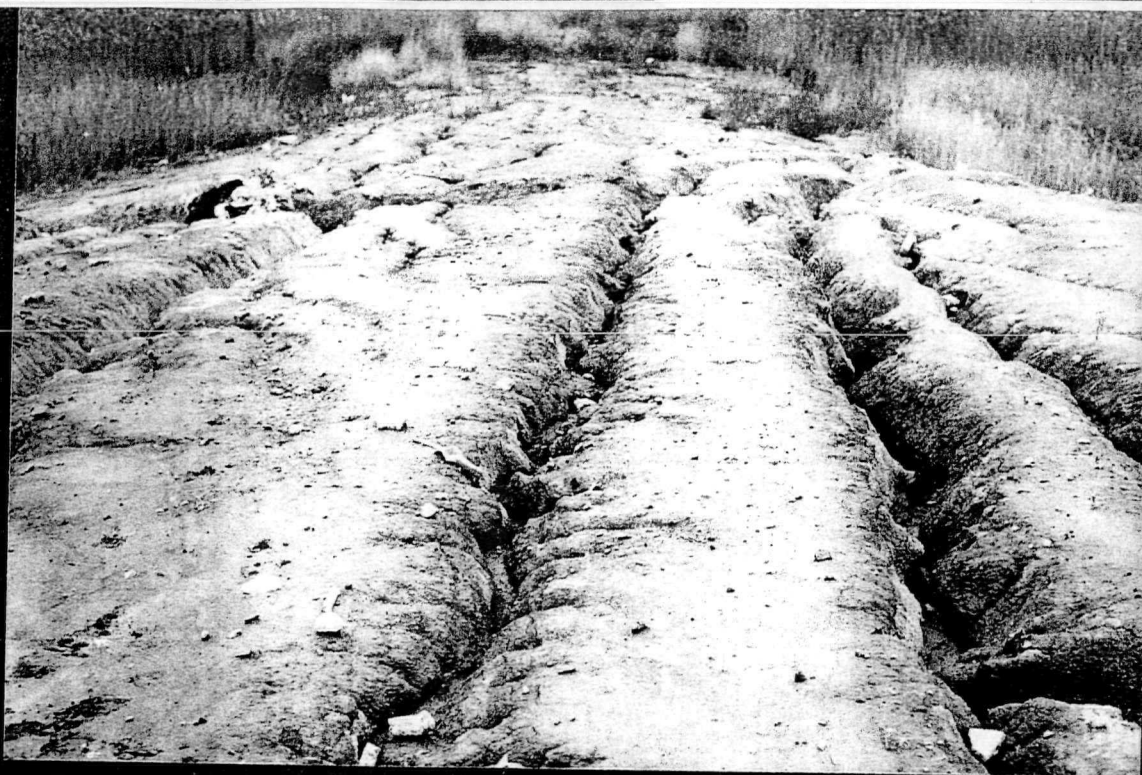
11-19-96 M. Mikulka  
Gary Development Landfill  
#21 -- View of western face of  
GDC landfill, from top of landfill  
and facing west. Note severe

erosion, cap material at toe of  
slope, and trash from landfill.

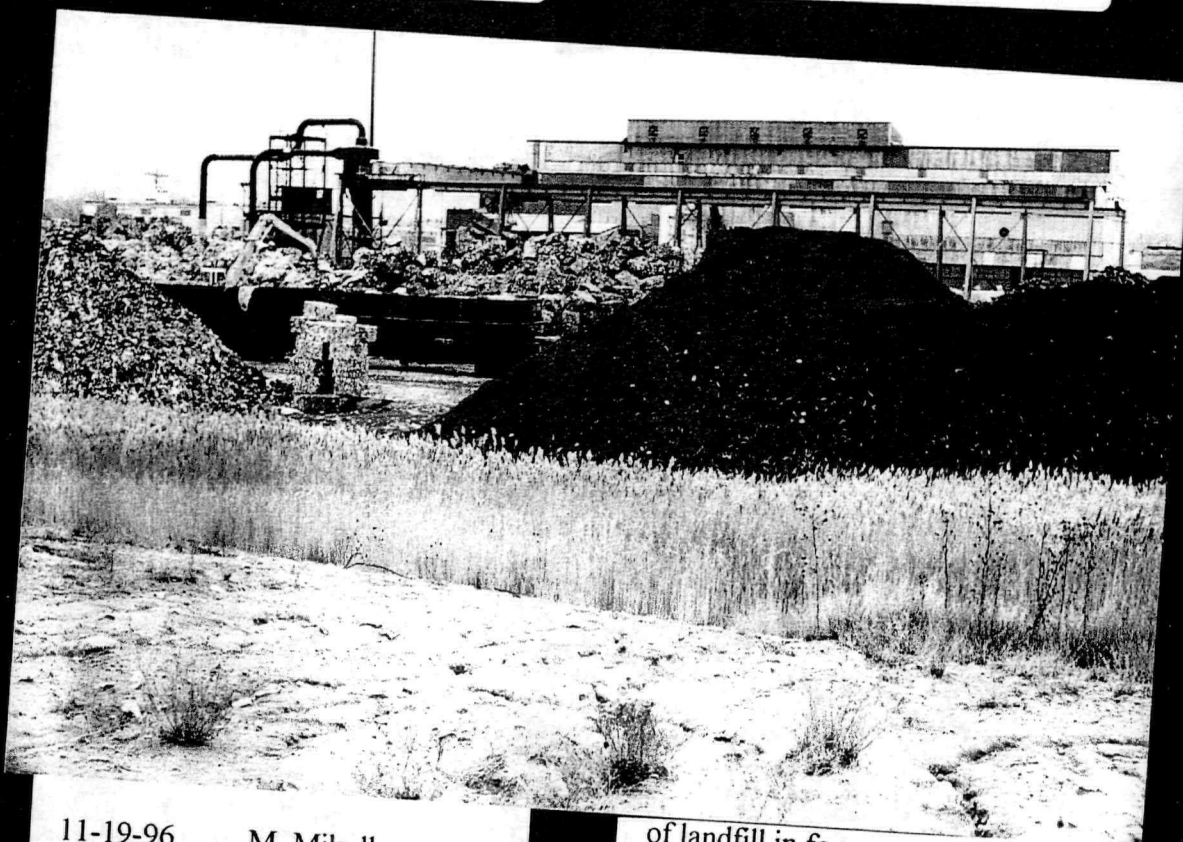
11-19-96 M. Mikulka  
Gary Development Landfill  
#22 -- View of AMG Resources  
facility as seen from W. Side of  
GDC Property. Note western face

of landfill in foreground, and  
depressed area at toe of slope,  
where storm water from western  
portion of landfill drains.

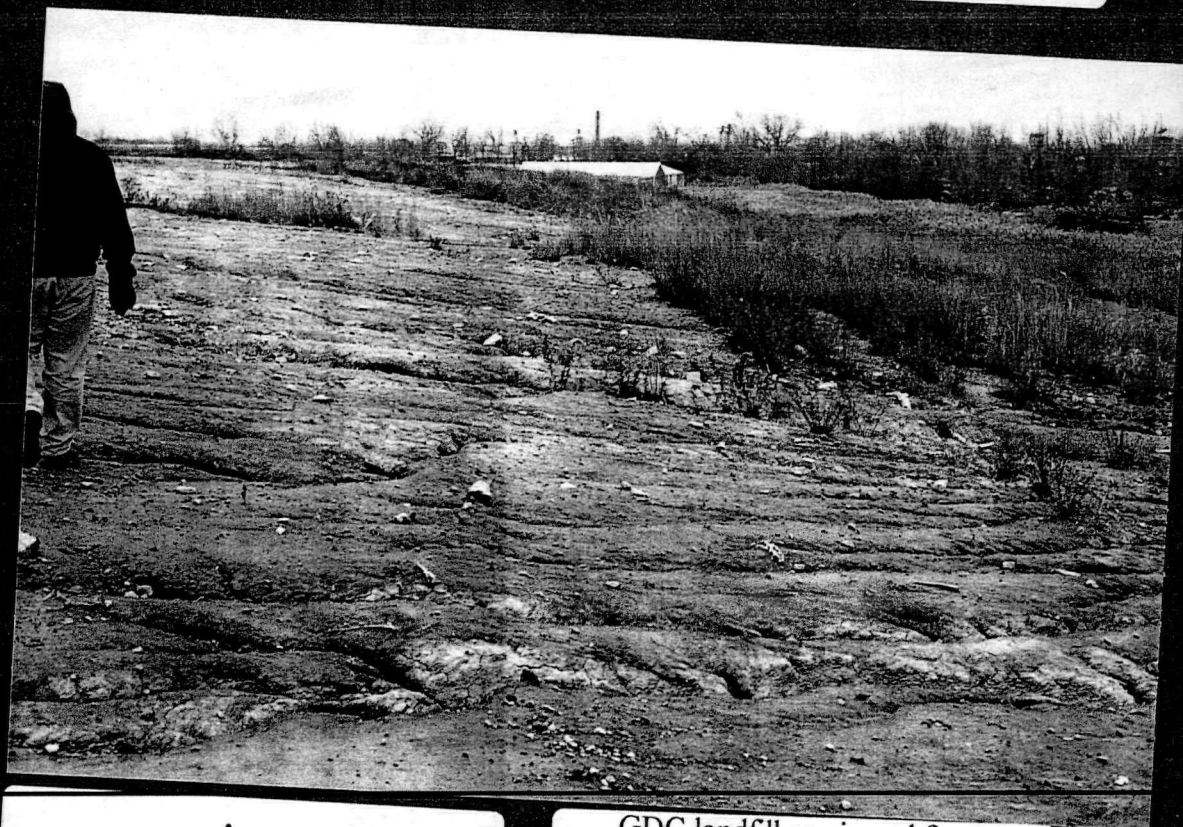
11-19-96 M. Mikulka  
Gary Development Landfill  
#24 -- View of western face of

GDC landfill as viewed from north  
to south. Note GDC offices in  
background. Note erosion  
problem along complete face, and  
lack of vegetative cover.

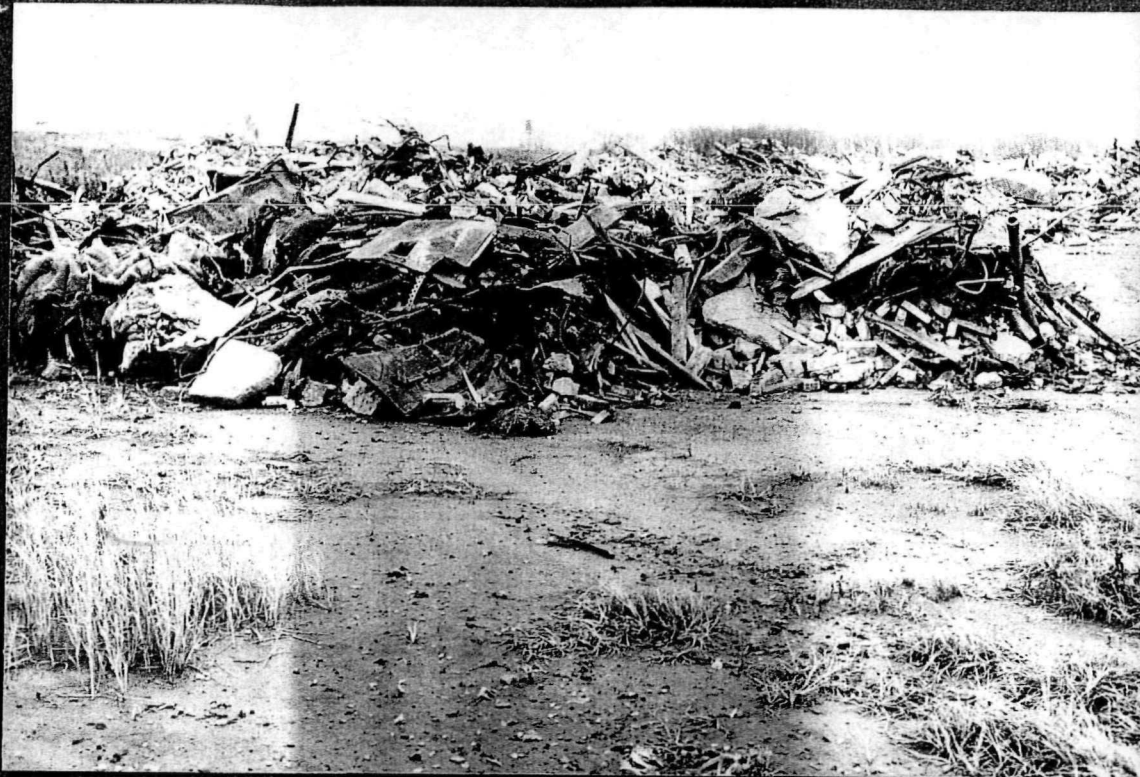
11-19-96 M. Mikulka  
Gary Development Landfill  
#24A -- Solid waste material  
(demolition debris) dumped at  
GDC landfill since closure of  
facility. This material is located at  
northwestern portion of the  
landfill, at top of slope adjacent to  
leachate/storm water collection  
pond. See also photo #19.
